# PLOUGH HOUSE, NEW STREET, DEDDINGTON, OXFORDSHIRE

## HERITAGE STATEMENT

**PROJECT:** Plough House, New Street, Deddington, Oxfordshire

**DOCUMENT TITLE:** Heritage Statement

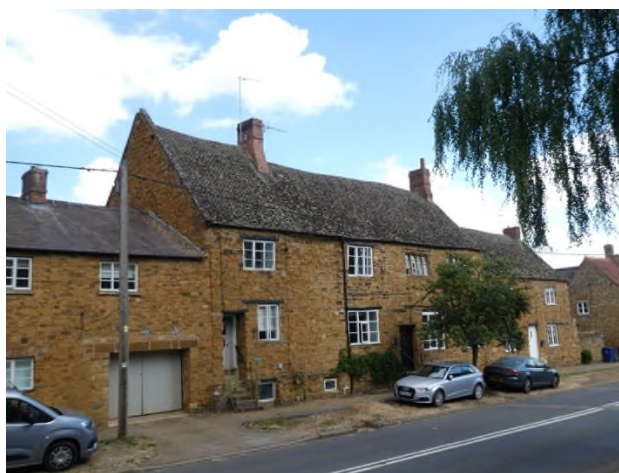
Figure 1: Front elevation of Plough and The Steps

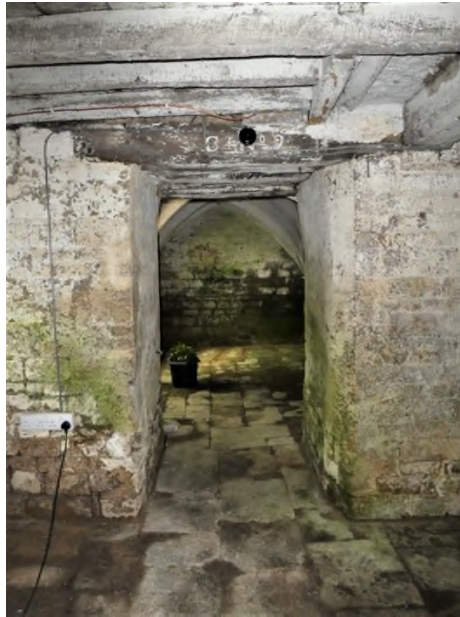
Figure 8: Entrance to the late medieval undercroft from the Phase 2 cellar

- 3.2.2 Phase 1 is a late 14<sup>th</sup> to 15<sup>th</sup> century undercroft. The entrance to the Phase 1 cellar is from the cellar below the sitting room. There is a timber lintel with Cr No. 2 painted on it, probably of 19<sup>th</sup> century date.

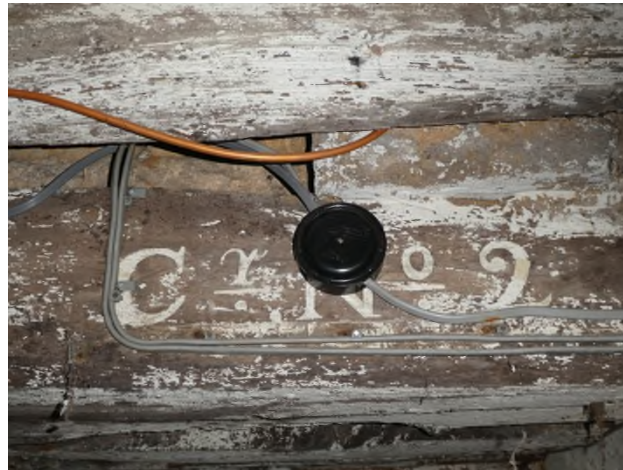
Figure 9: Painted sign recording the late medieval undercroft as *cellar no. 2*

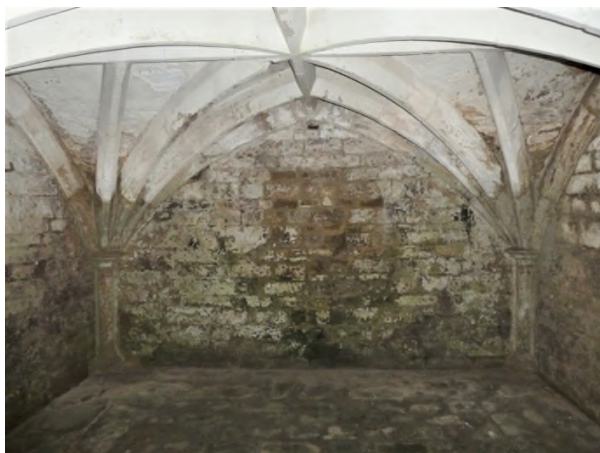
Figure 10: Rear wall of the cellar

- 3.2.3 The stone vaulted cellar below The Steps is characterised by deep chamfered ribs and tiercerons springing from wall shafts with moulded octagonal bases and capitals. The south-west wall (facing the road) includes a partly blocked doorway creating a slope presumably for beer barrels which, in turn, has been partially infilled to create a window opening. The doorway is flanked by blocked traceried windows. There is evidence for an area of removed masonry on the north-east side of the cellar. This relates to exploratory work that was undertaken to verify whether there was a tunnel connected to the Castle. No evidence was found for a tunnel. The floor is finished with flagstones.

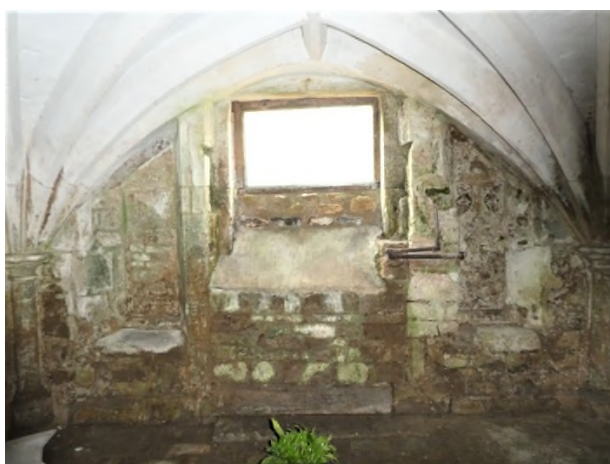
Figure 11: Front wall of the cellar which includes a partially infilled door and blocked windows

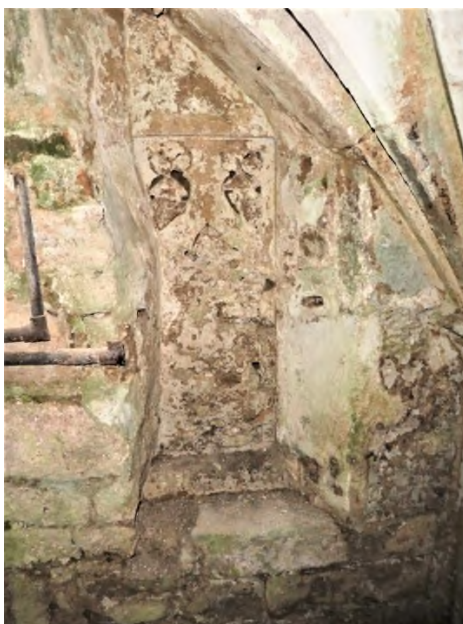
Figure 12: Blocked tracery window

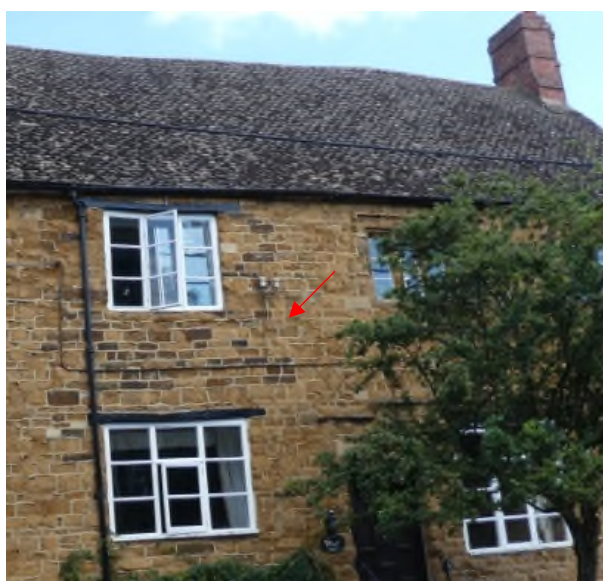
Figure 13: Apparent building break to the left of the front door at Plough House

3.2.4 Phase 2 is interpreted as a 17<sup>th</sup> century rebuild of an earlier structure, possibly a hall house with a chamber and service wing, which incorporated a late medieval undercroft. The exterior is characterised by coursed squared marlstone construction and a double pitched roof. There is a clear break in the pattern of the stone coursing on the left hand side of the front door which suggests two phases of construction or a substantial repair. To the right of this building break are two 4-light windows with plain chamfered stone mullions with drip moulds and a string course below which steps up where there was apparently a wider window. There is a partially infilled door opening with a stone lintel on the right hand side of the front elevation. The c. 1905 photograph shows that this door had been blocked up by this time. This contrasts with the current door which does not include any dressings and has a narrow timber lintel. The two windows to the left include chamfered timber lintels which is indicative of later developments in building styles.

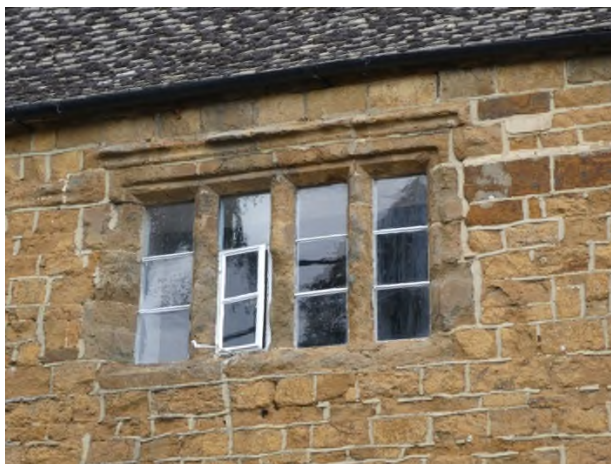
Figure 15: First floor stone mullioned window with hood mould

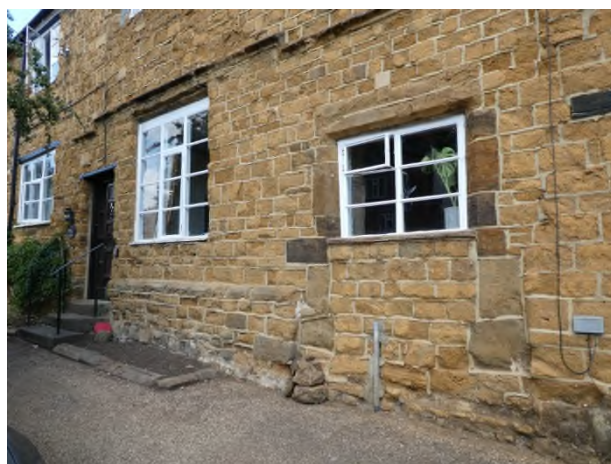
Figure 16: Partially infilled door on the right hand side of the front elevation, string course and modified window opening to the right of the front door

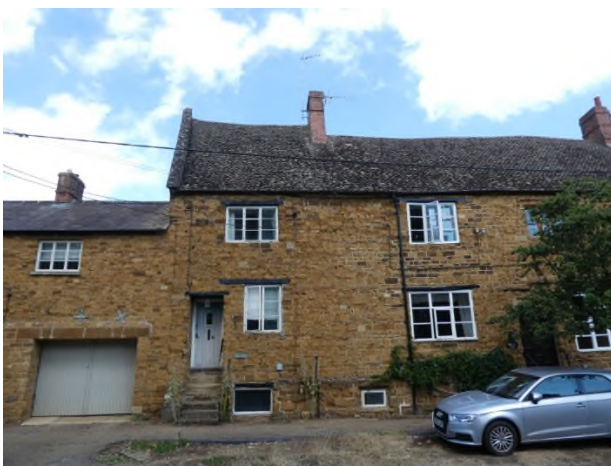
Figure 17: Window openings with timber lintels on the left hand side of the front elevation

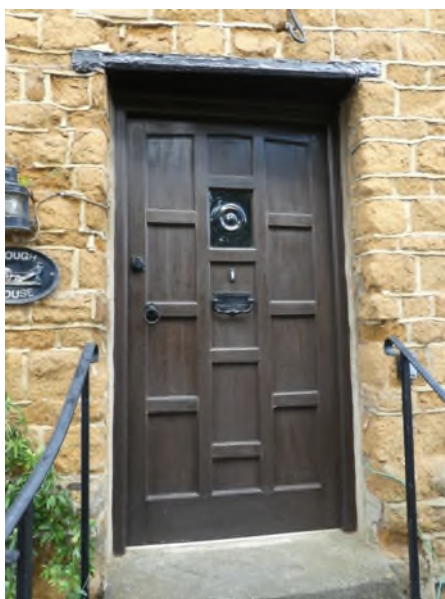
Figure 19: Existing front entrance with a slender timber lintel, no stone dressings and a modern door

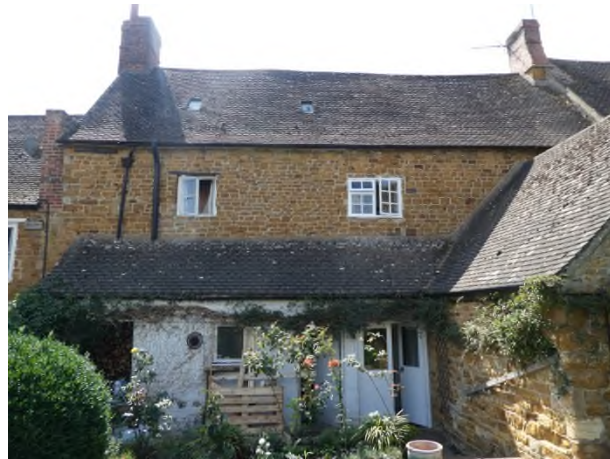
Figure 20: Rear elevation of Phase 2

- 3.2.5 The rear elevation is masked to a large extent by a single storey wing and a lean-to extension. The central and left hand side of the first floor can be viewed from the rear garden. There is a large panel of masonry that is in lien with the lean-to which is of different character to the masonry either side and includes straight joints. This section of masonry lines up with the large stone fireplace in the dining room and is likely to be associated with a chimney on this side of the building. There is a pattress plate in the upper left hand corner. The masonry in this area is fairly irregular and suggests a repair. The first floor window to the left includes a timber lintel, while the window to the right does not include any form of head detail. The building break that is apparent on the front elevation is not so clear on the rear elevation.

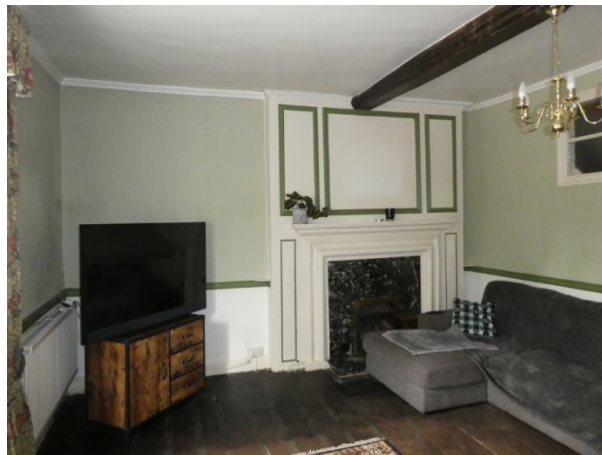
Figure 20: Axial beam and wide floor boards in the sitting room

3.2.6 **Sitting room:** The sitting room contains a double ogee axial beam and wide floor boards. There is an off-centre fireplace on the north-west side of the room that would have originally been roughly centrally positioned in the original room layout.

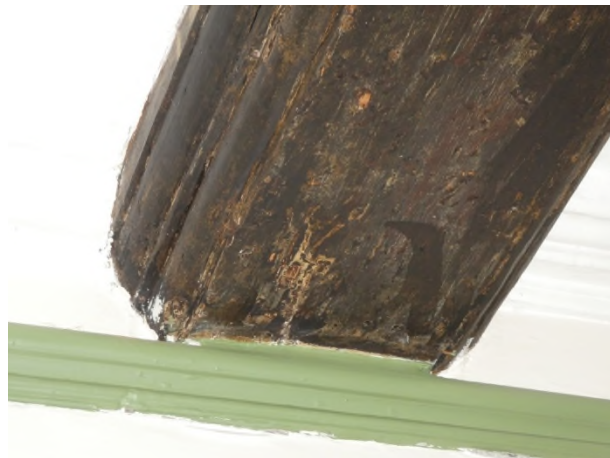
Figure 21: Detail of the double ovolo axial beam

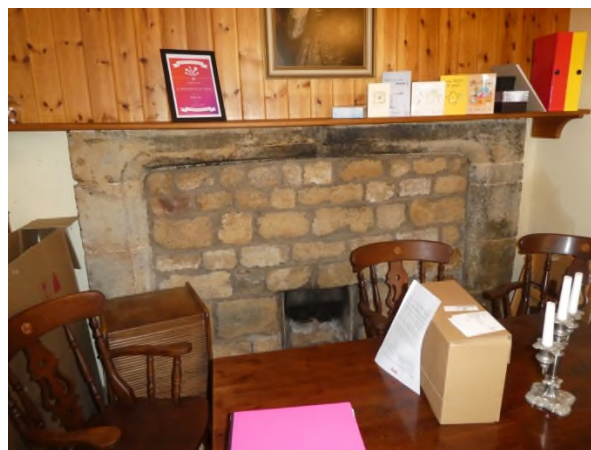
Figure 23: Detail of the fireplace in the dining room

3.2.7 **Dining room and kitchen:** The dining room and kitchen would originally have been a single room but was sub-divided in the 20<sup>th</sup> century. The interior is characterized by modern finishes. There is an early to mid-17<sup>th</sup> century stone fireplace with a depressed 4-centred arch along the rear wall. The original fireplace has been infilled with squared stones.

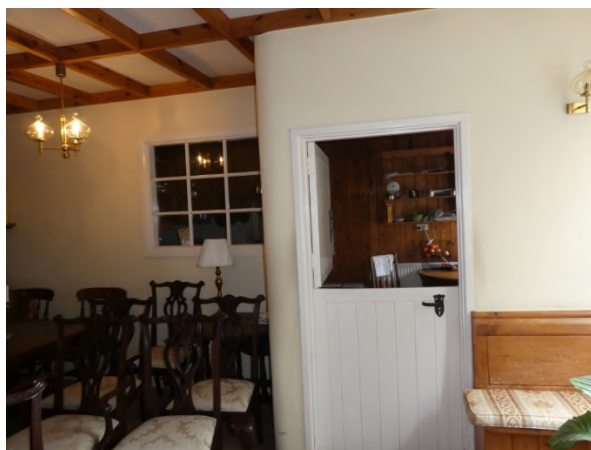
Figure 24: 20<sup>th</sup> century partitions in the dining room/kitchen

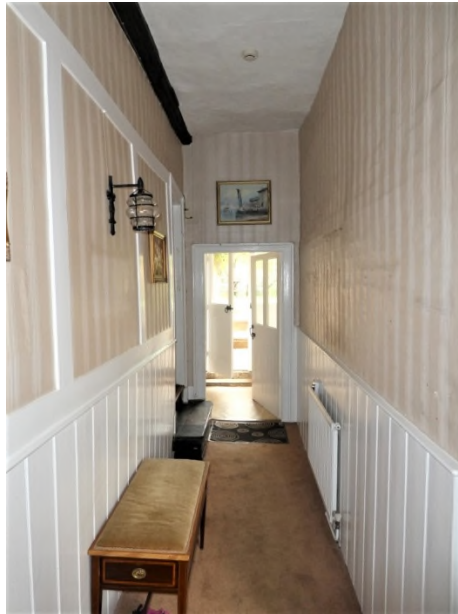
Figure 25: Entrance hall looking towards the rear door (note the double ovolo cross beam to the left)

- 3.2.8 **Entrance hall:** There is a double ovolo cross beam on the sitting room side of the entrance hall. There is no cross beam visible on the dining room side of the entrance hall. The entrance hall includes a front and a rear door and is therefore a through passage.

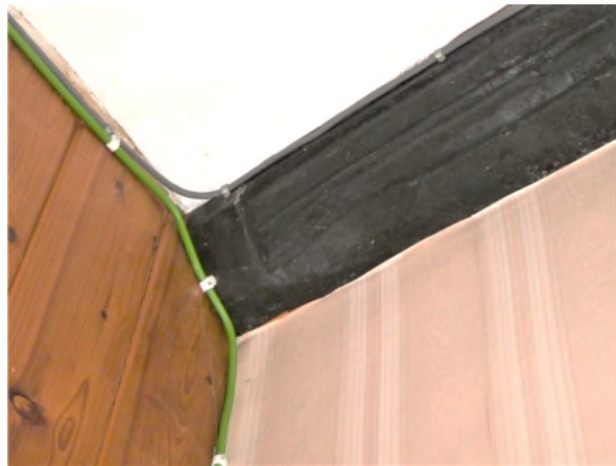
Figure 26: Double ovolo cross beam on the sitting room side of the entrance hall

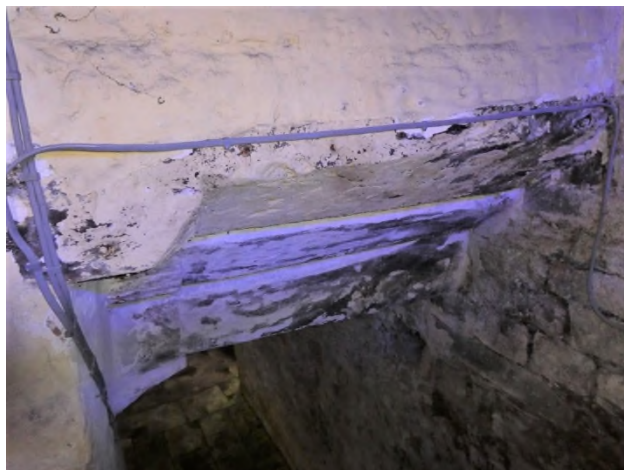
Figure 28: Stone lintel with a wide chamfer and flat-step stops at the entrance to the cellar

- 3.2.8 **Cellar:** The workshop provides access to a cellar below the sitting room. The entrance to the cellar includes a stone lintel with a wide chamfer and flat-step stops which suggest a 16<sup>th</sup> century or date for the entrance. The winder steps are stone. The cellar is lined with coursed squared stone and the floor is finished with flag stones. There is a chamfered axial beam with 3" chamfers and scroll stops. The existing joists are later replacements. There are mortices of 95-100mm wide which preserve the position and size of the original joists. The character of the axial beam and the width of the missing joists is consistent with a late 16<sup>th</sup> to 17<sup>th</sup> century date. There is a splayed opening on the south-west side of the cellar which includes a slope, presumably for barrels, and a modern window. The timber lintel includes soffit tenon mortices associated with the original joists.

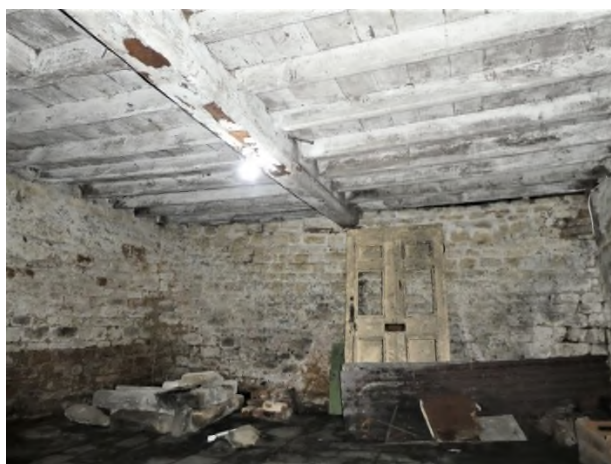
Figure 29: Axial beam and replacement joists in the cellar

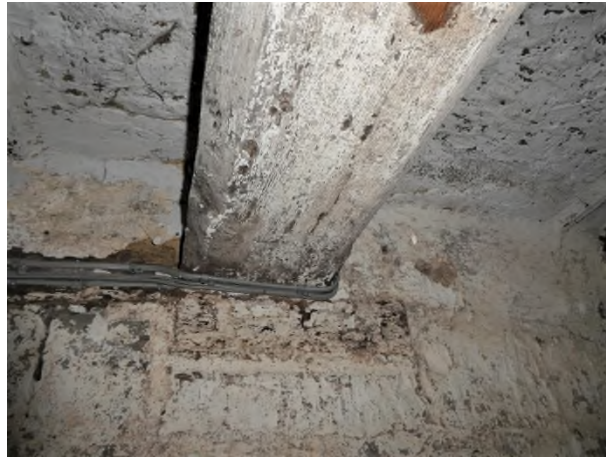
Figure 30: Detail of the wide chamfered axial beam with scroll stops in the cellar

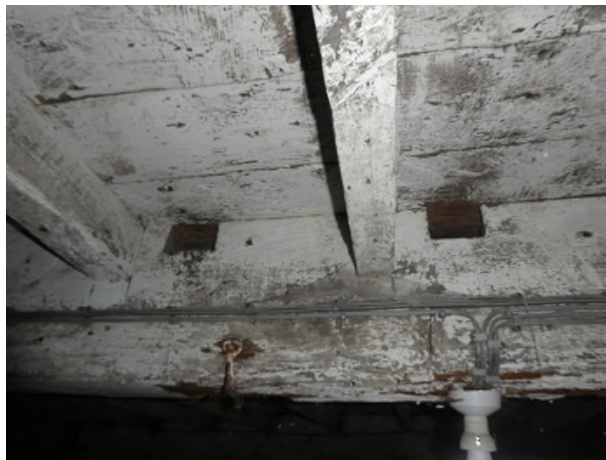
Figure 31: Detail showing mortises for the original joists

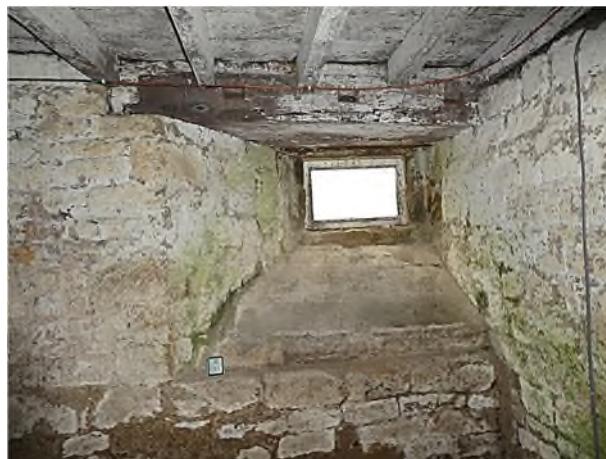
Figure 32: Splayed opening with slope and lintel with mortises for joists

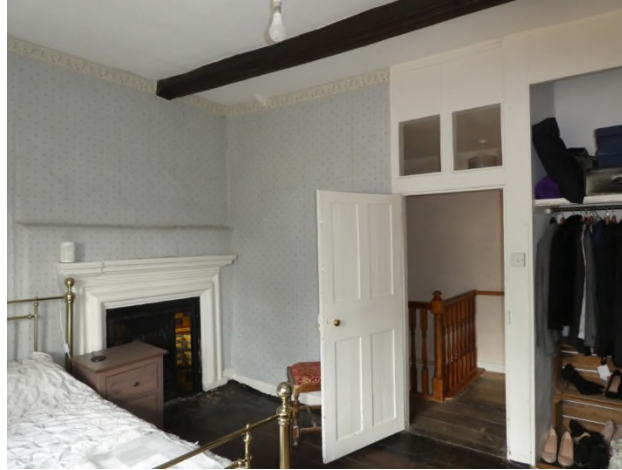
Figure 33: Axial beam with double ovolo mouldings in bedroom 1

3.2.9 **Bedroom 1:** Bedroom 1 is partly defined by a partition on the landing. It is not clear when the partition was inserted but the 4-panelled door would suggest a 19<sup>th</sup> century date. Bedroom 1 contains an axial beam with double ovolo mouldings with scroll stops and this relates to the 17<sup>th</sup> century house. The wide floor boards of around 12" wide are consistent with a 17<sup>th</sup> century date. There is a shallow projecting chimney breast in the western corner of the room. The original fireplace was altered in the early 18<sup>th</sup> and late 19<sup>th</sup> centuries. The splayed window

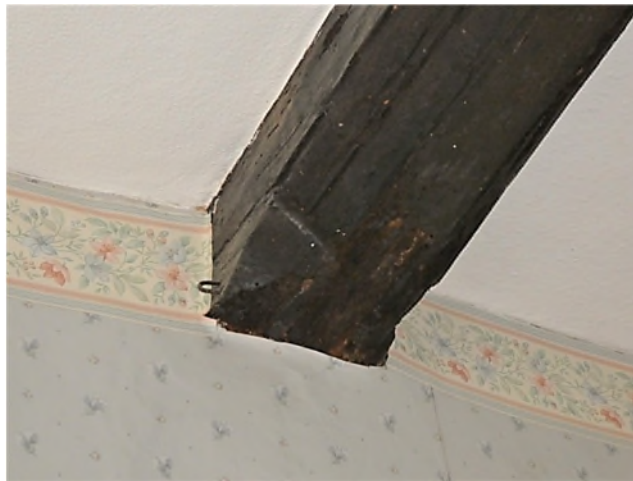
Figure 34: Detail of the double ovolo mouldings and scroll stop on the axial beam in bedroom 1

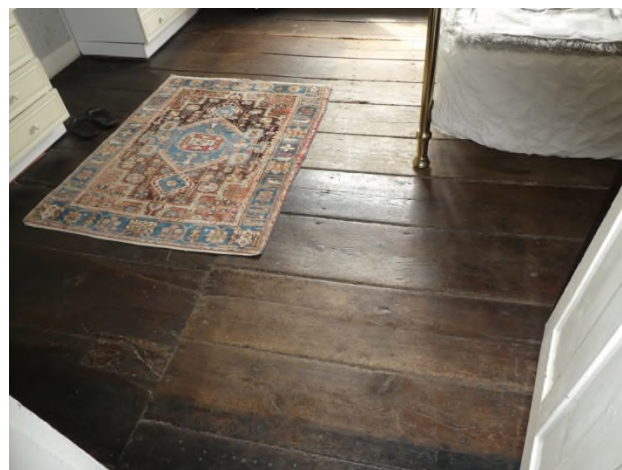
Figure 35: 12" wide floor boards in bedroom 1

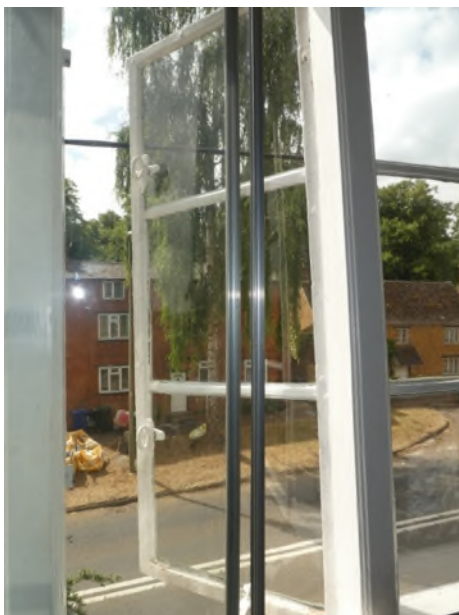
Figure 36: Side opening iron casement with evidence for lead comes on the south-west side of bedroom 1

on the south-west side of the room includes a 3-light window with wooden mullions and a central iron casement. The frame of the casement includes blocked holes which demonstrate that it was originally a leaded light. The style of the window with a pair of window catches suggests a 19<sup>th</sup> century date but may be earlier. The partition on the south-east side of the room has a 20<sup>th</sup> century finish.

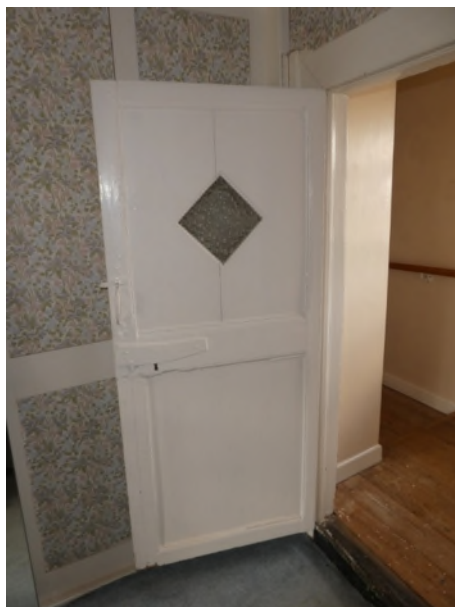
Figure 37: Late 17<sup>th</sup> century 2-panelled door to bedroom 2

3.2.10 **Bedroom 2:** Bedroom 2 is accessed through an altered 2-panelled door with an upright door handle and decorative H-hinges. The style of the door suggests a late 17<sup>th</sup> to early 18<sup>th</sup> century date. The wide architrave is later, probably late 18<sup>th</sup> or possibly early 19<sup>th</sup> century. Bedroom 2 includes a cross beam between bedrooms 1 and 2. The wall finish between the two rooms is 20<sup>th</sup> century. This room has a lath and plaster ceiling which is presumably masking an axial beam. The 4-light window on the south-west side of the room is characterized by plain chamfered mullions and a side opening iron casement with a hook stay and a catch with a decorative back plate which suggests a late 17<sup>th</sup> century date.

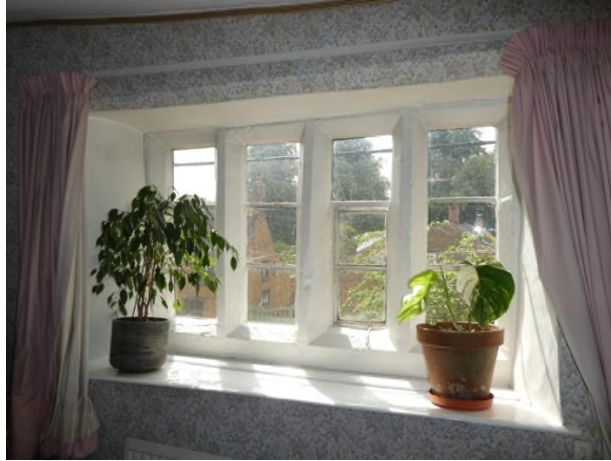
Figure 38: Plain chamfered mullion window in bedroom 2

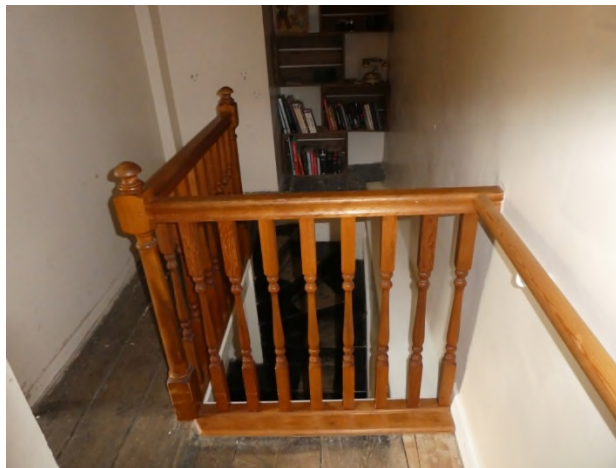
Figure 39: Wide floor boards and a modern balustrade in the landing

3.2.11 **Landing:** The landing would have originally formed part of bedroom 1 and has wide floorboards, as is the case in bedroom 1. The balustrade at the top of the stairs is relatively modern. There are narrower boards on the south-east side of the balustrade and a step up to the passage that provides access to bedroom 2. The window on the north-east side of the passage is relatively modern.

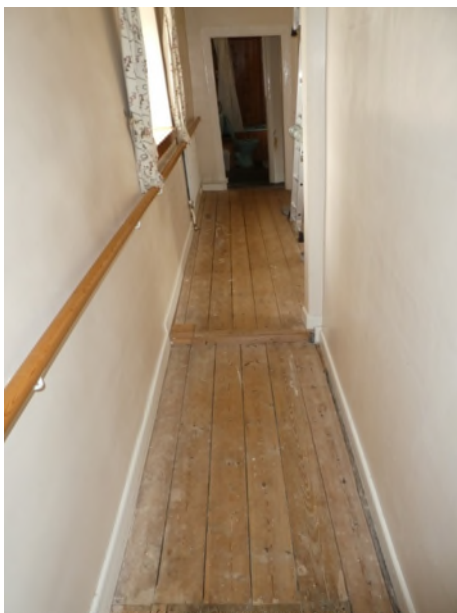
Figure 40: Narrower boards and a step up in the passage leading to bedroom 2 and the bathroom/bedroom 3

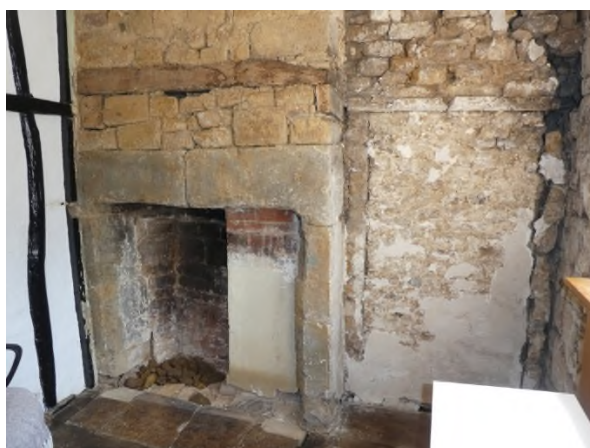
Figure 41: Stone fireplace and blocked door on the south-east side of bedroom 3

3.2.12 **Bedroom 3 and bathroom:** Bedroom 3 and the first floor bathroom are accessed through a door opening with a wide architrave. Both spaces have wide floor boards. Bedroom 3 is accessed through a modern door. There is a stone fireplace on the south-east side of the room. This fireplace includes stone jambs and two sections of stone forming the lintel. The edges of the fireplace have been hacked back and any detail of chamfers etc. has been lost. There is a horizontal timber above the fireplace and evidence for a lime clay wall finish. There is a blocked door with a timber lintel on the right hand side of the chimney breast. The 4-light window on the south-west side of the room includes plain chamfered mullions and a side opening iron casement with a quadrant stay and a catch with a decorative back plate. These details suggest a late 17<sup>th</sup> to early 18<sup>th</sup> century date. The partition forming the bathroom is modern.

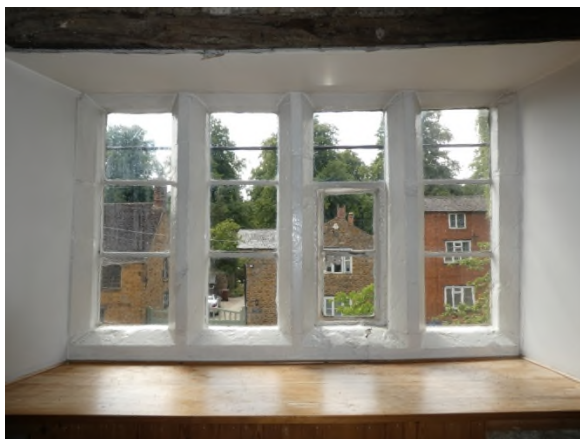
Figure 42: Plain chamfered mullion window on the south-west side of bedroom 3

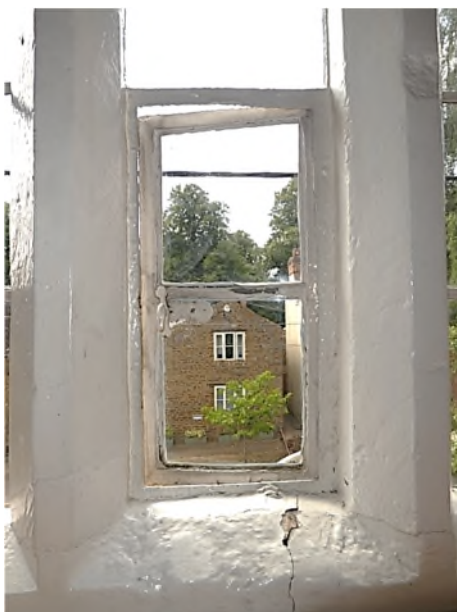
Figure 43: Detail of the iron casement with catch and decorative back plate

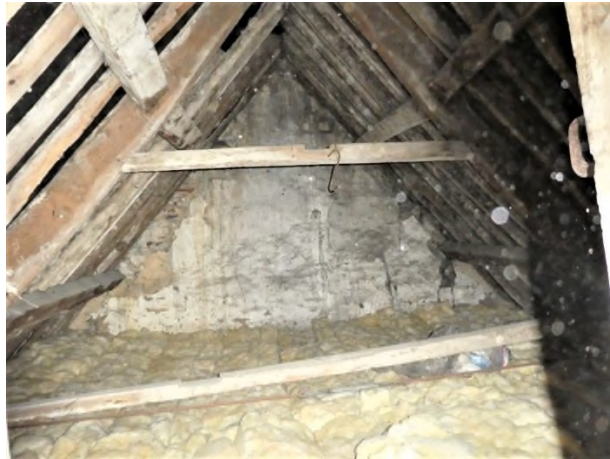
Figure 44: Butt purlin roof structure

3.2.13 **Roof structure:** The roof is characterized by a butt purlin roof structure with halved or tenoned apex joints to rafters, no ridge plank. There are two stud partitions with a lath and plaster finish indicating that the attic has been used as part of the accommodation historically. The partition on the north-west side of the attic includes a plank and batten door. The character of the partitions suggests an 18<sup>th</sup> to early 19<sup>th</sup> century date, possibly associated with the conversion of the property from a house to an inn.

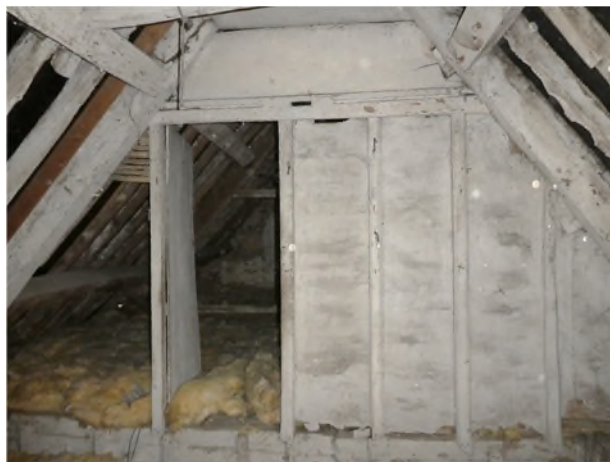
Figure 45: Stud partition on the north-west side of the central bay

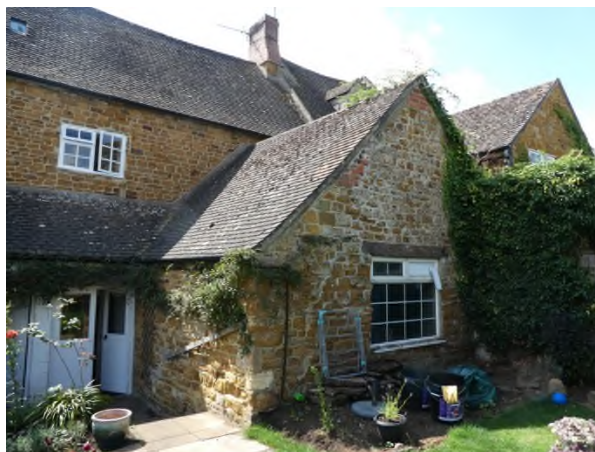
Figure 46: Single storey rear wing

3.2.14 **Workshop:** The rear wing is a single storey extension of coursed squared marlstone construction with a gabled roof finished with modern tiles. The north-east elevation includes a window with a timber lintel and a modern upvc window. Internally, this opening is splayed. There is evidence for repairs characterized by changes to the character of the masonry and bricks. There are quoins on the eastern corner.

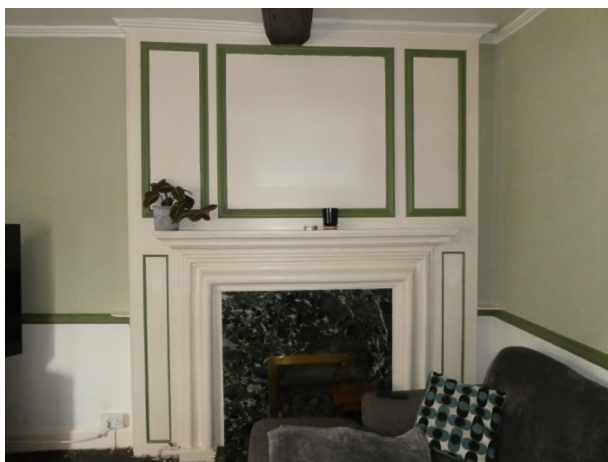
Figure 47: Early 18<sup>th</sup> century fireplace and a paneled surround

- 3.2.15 **Workshop:** The roof structure is characterized by a collared central truss with two rows of butt purlins. The tie beam includes chamfers and a curved stop which may be a scroll or ogee. There are some mortices along the soffit of the tie beam suggesting that the tie beam has possibly been reused. There are both replacement and doubled up rafters. The roof apex includes a ridge plank which is a later, perhaps 20<sup>th</sup> century, replacement or alteration to the roof structure. There is a projecting horizontal timber with a central section of beam that creates a cantilevered gable structure on the south-west side of the room. It is unclear what this relates to.
- 3.2.16 **Sitting room:** Early 18<sup>th</sup> century alterations in the sitting room include the insertion of a bolection fireplace with a paneled surround.

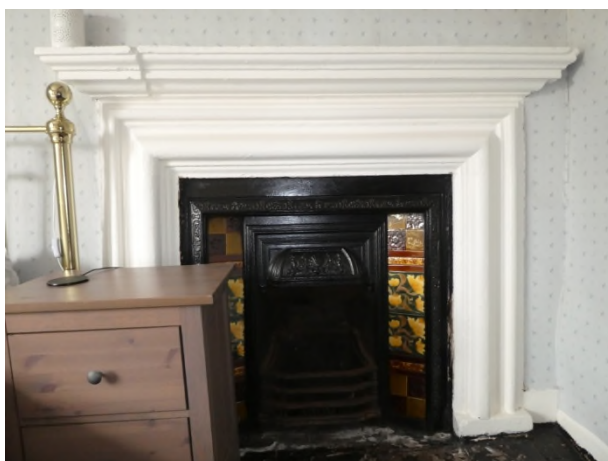
Figure 48: Early 18<sup>th</sup> century bolection fireplace in bedroom 1

- 3.2.17 **Bedroom 1:** There is a stone fireplace surround with bolection mouldings on the north-west side of bedroom 1. This relates to the early 18<sup>th</sup> century alterations to the house.

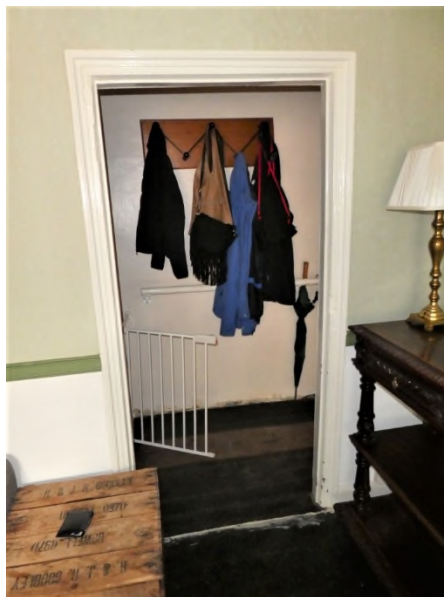
Figure 49: Door opening from the sitting room to the stairs

3.2.19 **Sitting room:** Based on the style of the door architrave, it appears that a partition for a staircase enclosure was inserted in the early 19<sup>th</sup> century, possibly late 18<sup>th</sup> century.

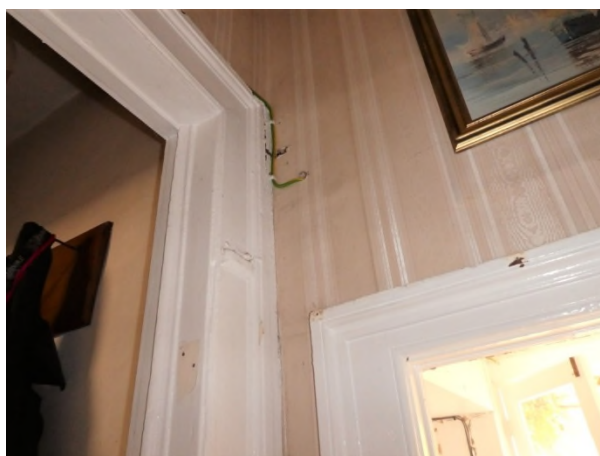
Figure 50: Architraves to the rear door and door to the stairs from the entrance hall

3.2.20 **Entrance hall:** The architrave to the door to the staircase on the north-east side of the entrance hall is of late 18<sup>th</sup> to early 19<sup>th</sup> century style. The architrave to the rear door of the entrance hall is also of late 18<sup>th</sup> to early 19<sup>th</sup> century date. The part-glazed door is a 20<sup>th</sup> century replacement. The architrave to the dining room is plain with a bead and could be of late 18<sup>th</sup> to early 19<sup>th</sup> century date. The door is a 20<sup>th</sup> century replacement. The 4-panelled door and architrave from the entrance hall to the sitting room are late 19<sup>th</sup> century. The style of the door architrave to the sitting room and the matchboard dado probably relate to the same phase of internal alteration. The applied boards above the dado appear to be later, probably 20<sup>th</sup> century.

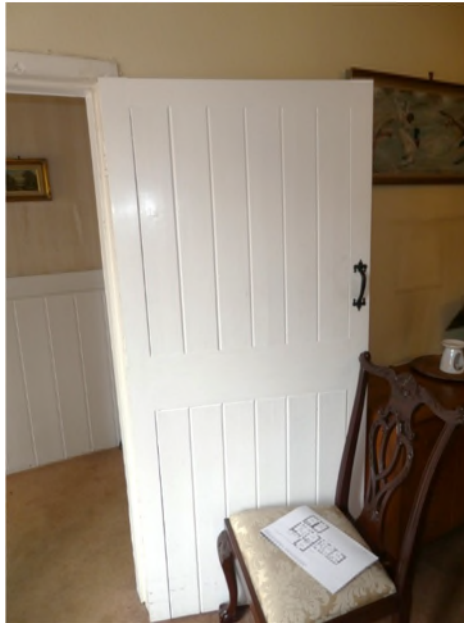
Figure 51: Door to the dining room from the entrance hall

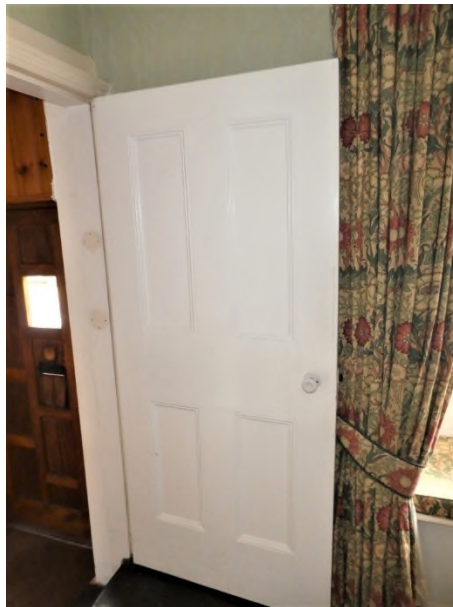
Figure 52: Late 19<sup>th</sup> century door to the sitting room

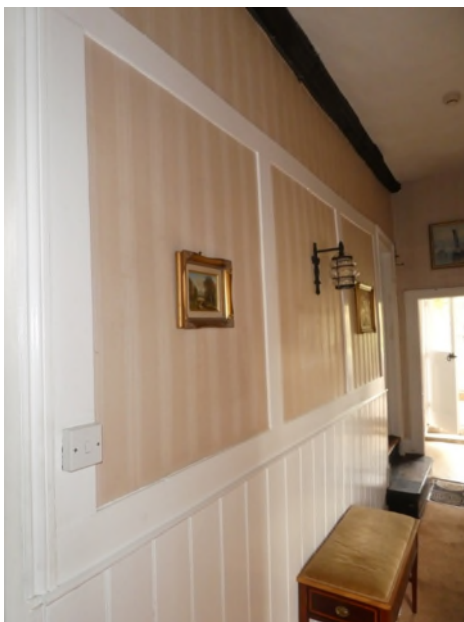
Figure 53: Late 19<sup>th</sup> century matchboard dado with probably 20<sup>th</sup> century applied boards above

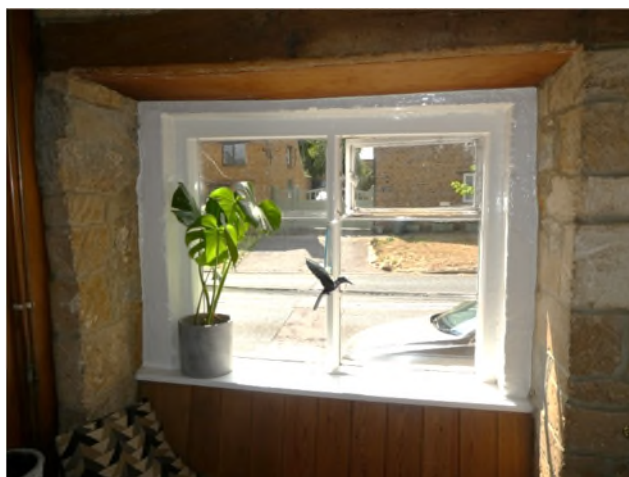
Figure 54: Late 19<sup>th</sup> century window in an earlier frame in the kitchen

3.2.21 **Kitchen:** The chamfered mullion window with an upper side opening casement appears to be of 19<sup>th</sup> century date.

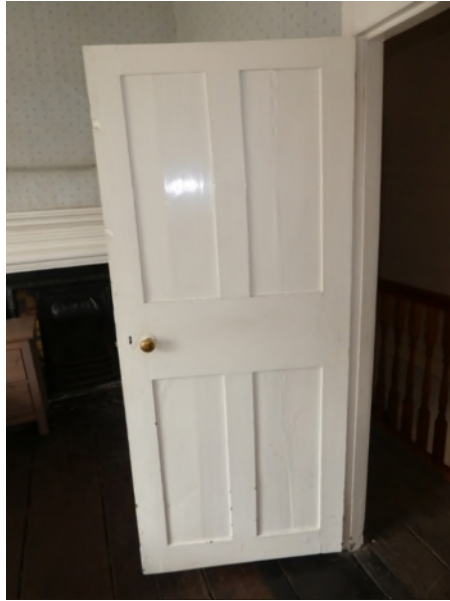
Figure 55: 4-panelled door with plain sunk panels leading from the landing to bedroom 1

3.2.22 **Bedroom 1:** The partition forming the bedroom and landing may have been inserted in the early 19<sup>th</sup> century. This is based on the style of the 4-panelled door to bedroom 1. The cast iron register grate with tiled sides is of late 19<sup>th</sup> century date.

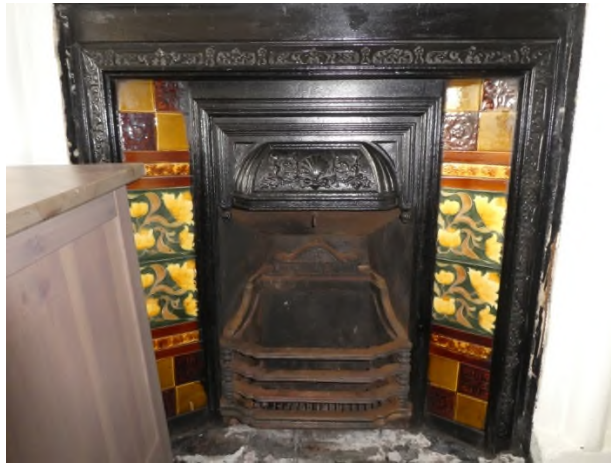
Figure 56: Late 19<sup>th</sup> century register grate in bedroom 1

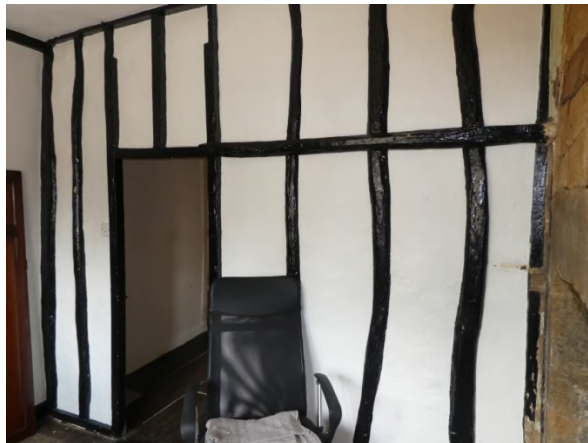
Figure 57: Stud partition between bedroom 3 and the bathroom

3.2.23 **Bedroom 3/bathroom:** These spaces are sub-divided by a stud partition which is of 18<sup>th</sup> to early 19<sup>th</sup> century character. A brick flue has been inserted on the right hand side of the fireplace, probably in the 19<sup>th</sup> century.

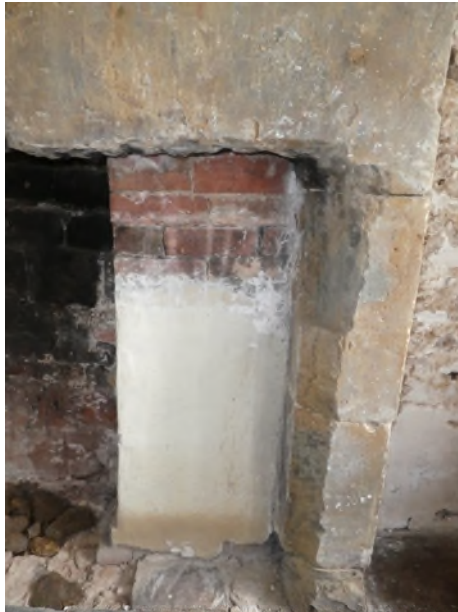
Figure 58: Brick flue inserted into the 17<sup>th</sup> century fireplace

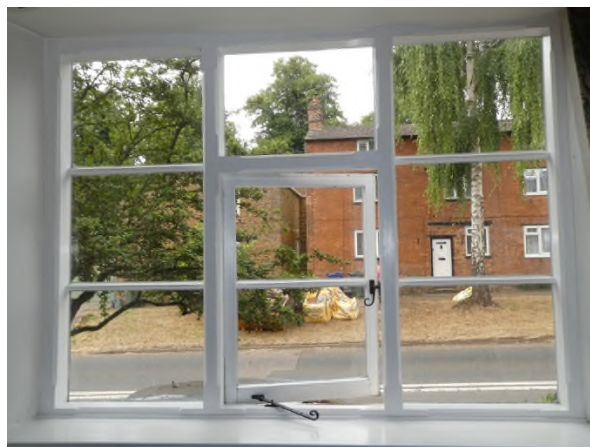
Figure 59: 20<sup>th</sup> century replacement window – sitting room

3.2.24 **Sitting room:** Window with chamfered mullions and a transom for a central casement.

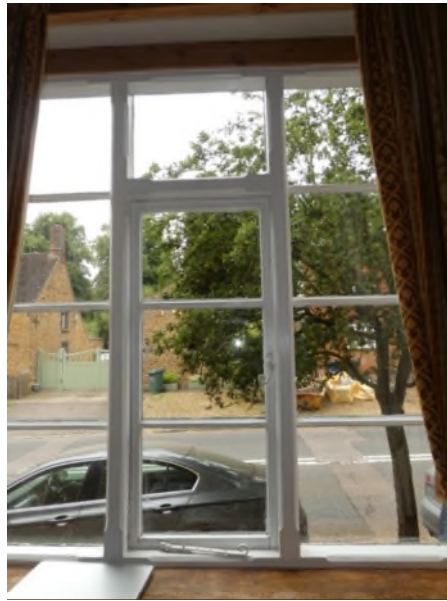
Figure 59: 20<sup>th</sup> century replacement window – dining room

3.2.25 **Dining room:** Window with chamfered mullions and a transom for a central casement, 20<sup>th</sup> century partition and ceiling.

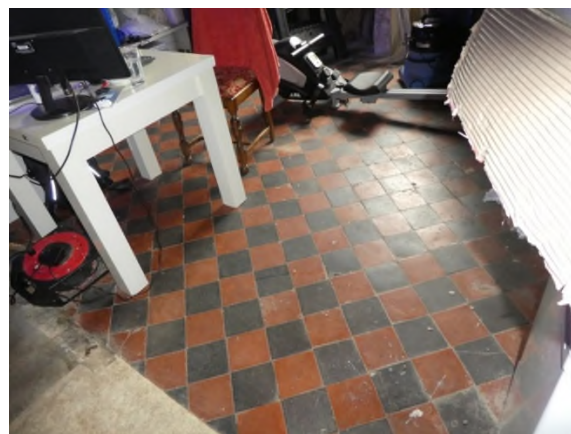
Figure 61: Tiled floor in the workshop

3.3.27 **Workshop:** The workshop includes a red and black tile floor finish which is typical of late 19<sup>th</sup> and early 20<sup>th</sup> century style.
